Pathway Keyplan 1:1250

Brinton Park Pathway Improvements

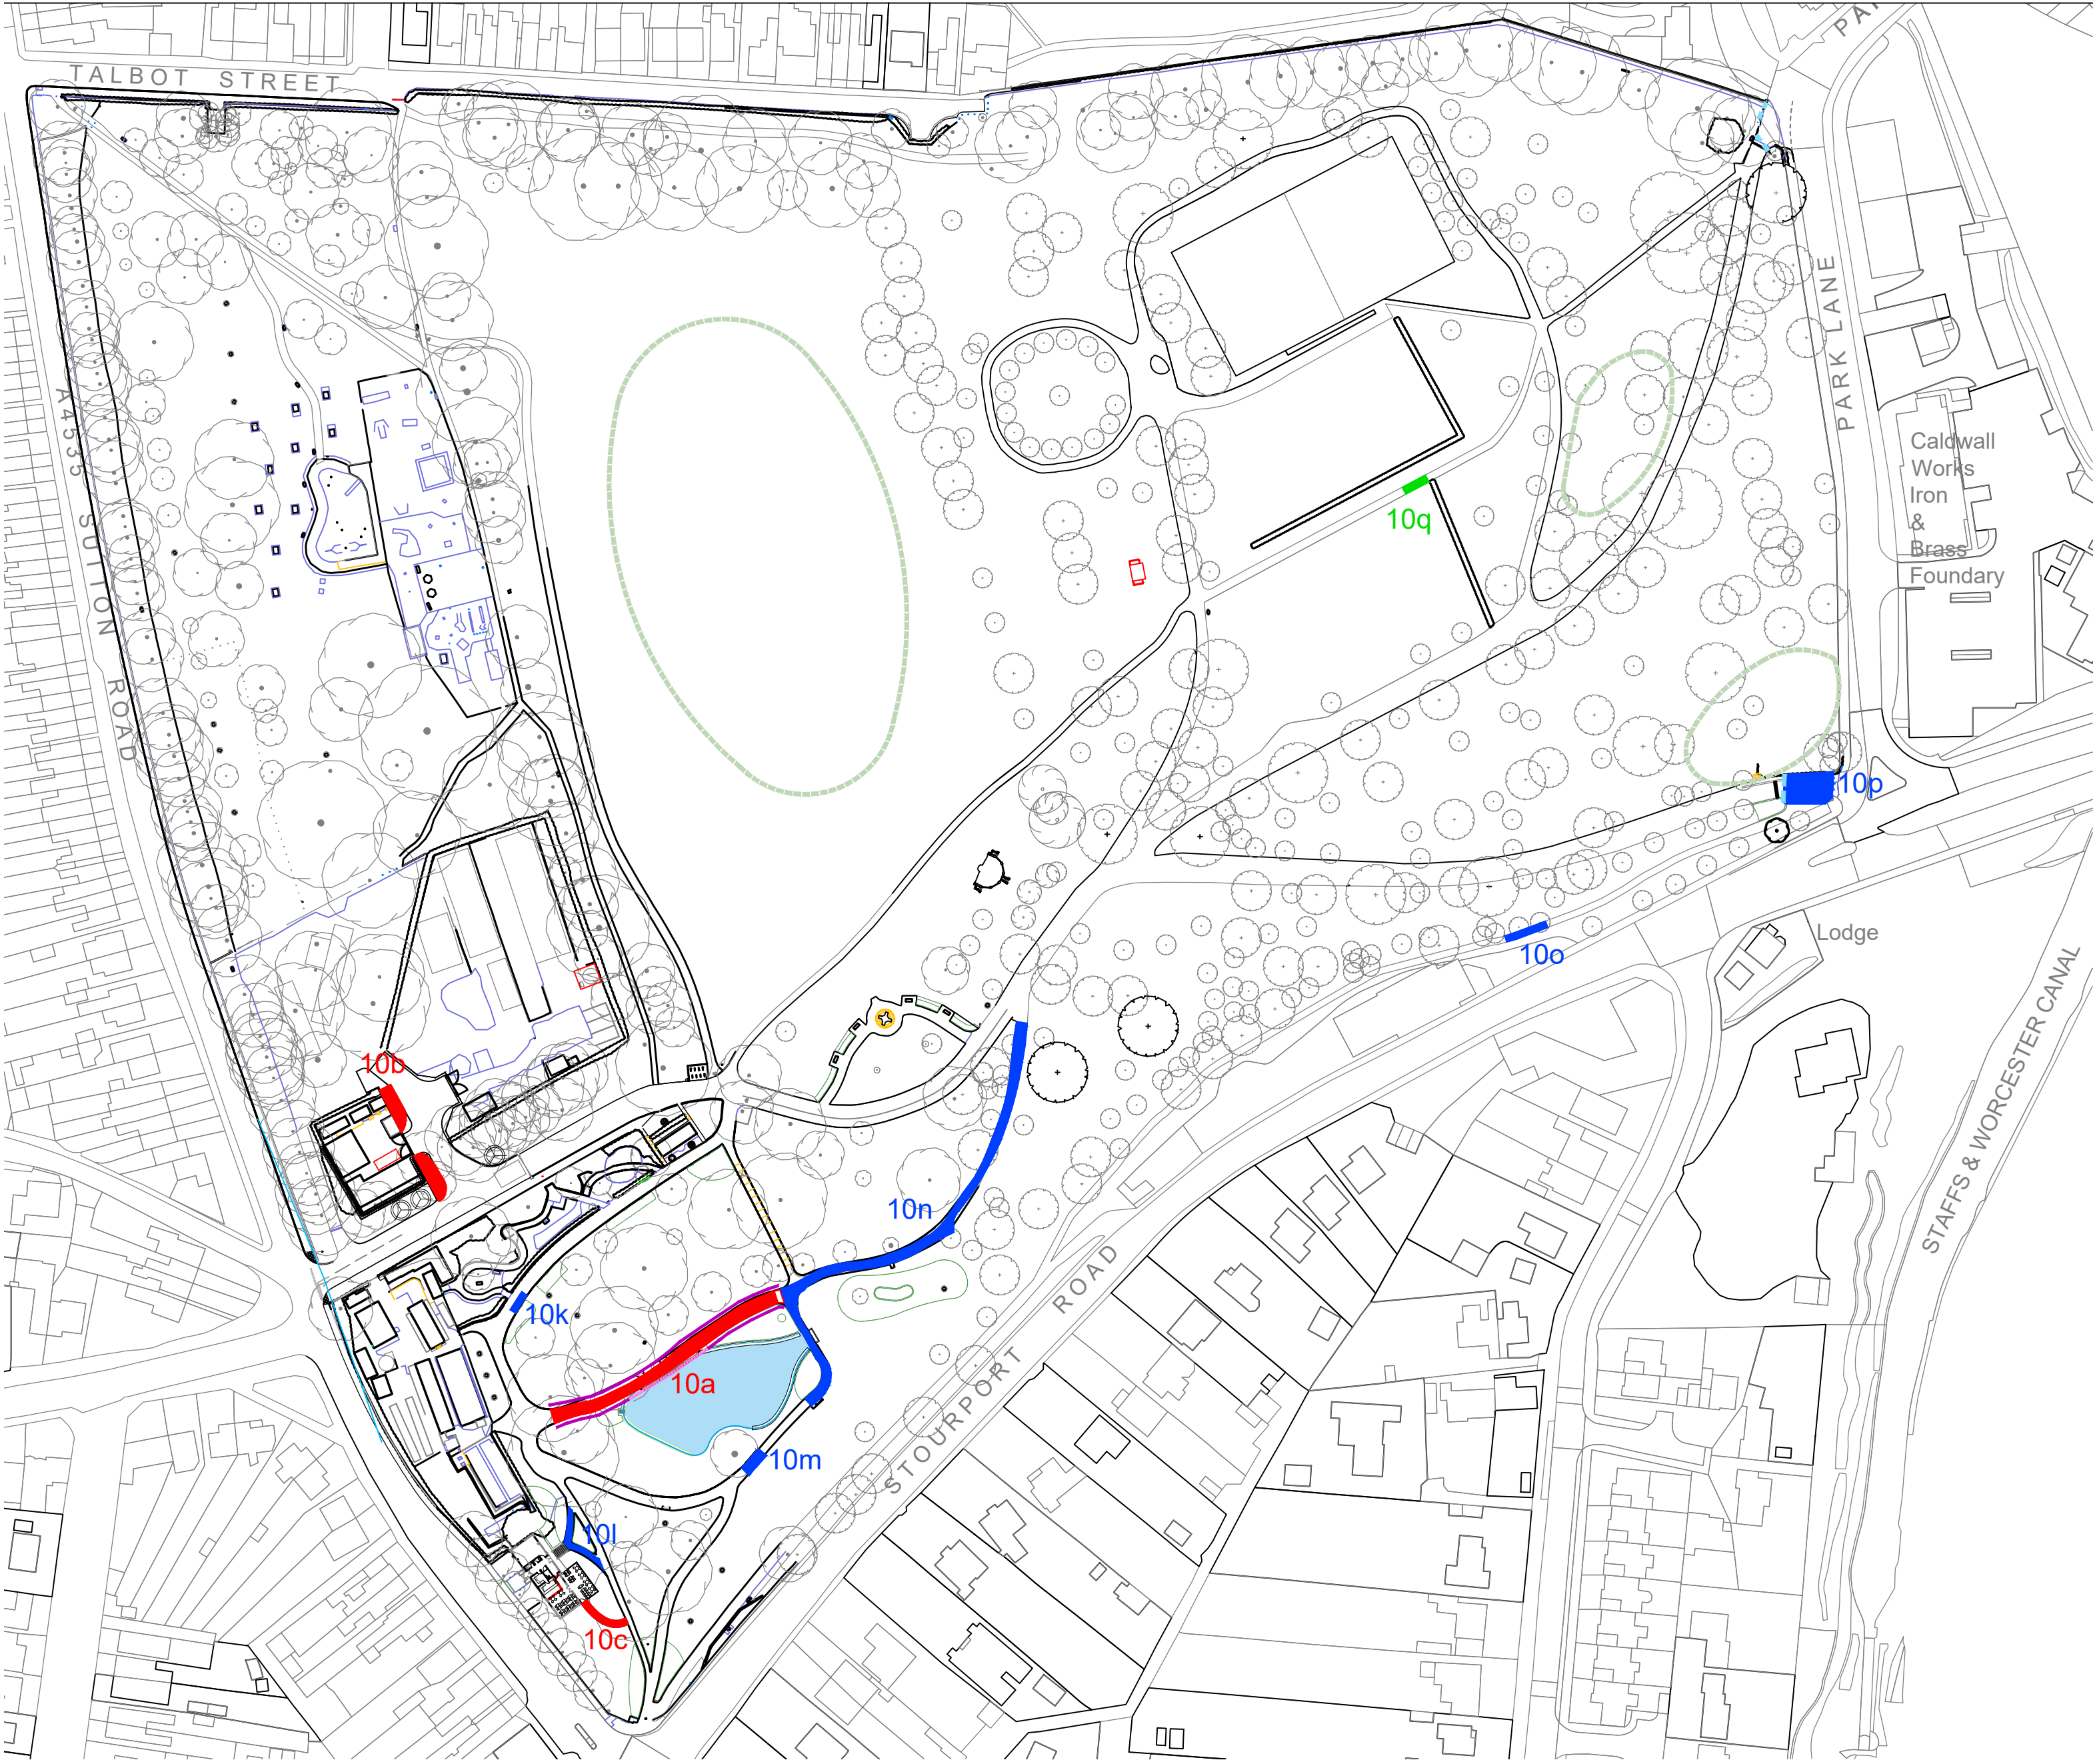
- New pathways (bitumen with PCC pin kerb)
- Pathway resurfacing (bitumen overlay, reset existing kerbs)
- Pathway patch repairs (bitumen overlay)
- Reclaimed blue terracotta edging (to new pathway to north of pool only)
- Stone retaining wall structure to north of pool
- New cobble setts (2 x strips)

New pathways (bitumen with PCC pin kerb, unless stated as otherwise below)

- a New section of pathway to north of reinstated pool (with reclaimed terracotta edging)
- b New section of pathway leading to car park
- c New ramped pathway leading to Sons of Rest Pavilion terrace

Pathway Resurfacing (bitumen overlay, reset existing kerb)

- R Resurface small section of pathway linking Senses Garden to pool area
- l Resurface pathways to leading up to Sons of Rest Pavilion
- m Resurface small section of pathway to south side of reinstated pool
- n Resurface full length of pathway to east of reinstated pool
- o Resurface small section of pathway (approx. 10m long)
- p Resurfacing to Stourport Road / Park Lane entrance

Pathway Patch Repairs (bitumen overlay)

- q Patch repairs to small section of pathway
